Integrated Fibre-Optic Sensor Networks as Tools for Monitoring Strain Development in Bridges during Construction

Liam J. Butler, Niamh Gibbons, Campbell Middleton and Mohammed Z.E.B. Elshafie

Department of Engineering, University of Cambridge, UK

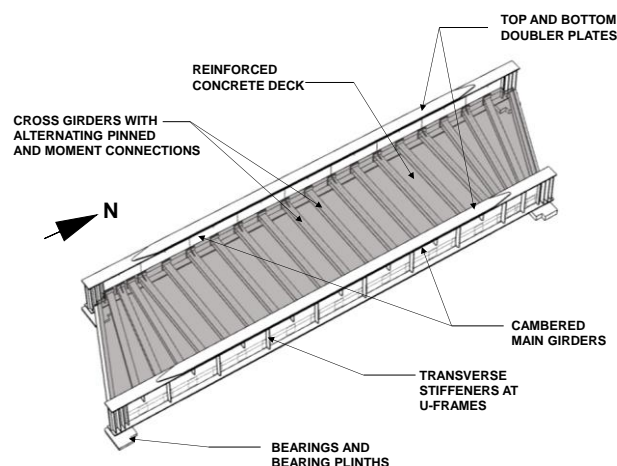
Figure 1. Schematic structural layout of Intersection Bridge 5.

The bridge instrumented as part of this work is referred to as Intersection Bridge 5. The superstructure includes a pair of I-shaped steel girders, a reinforced concrete composite deck supported on an array of cross girders. The main girders are pre-formed to produce a camber and include a series of transverse stiffeners and top and bottom flange doubler plates. The bridge is simply supported at the ends of the main girders on four bearing plinths. A schematic of the main superstructure is presented in Figure 1 and the completed structure is shown in Figure 2.

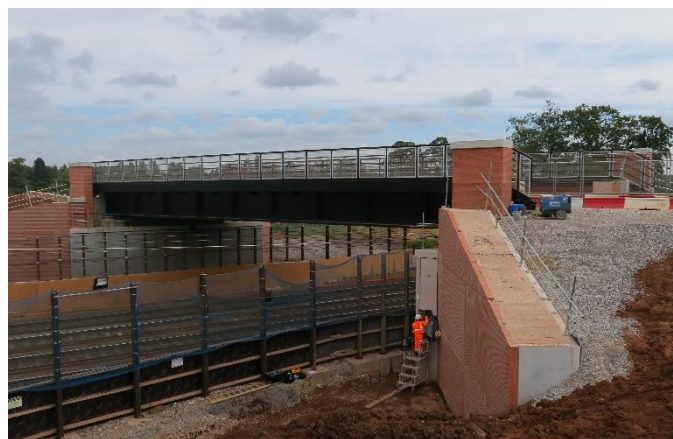
Figure 2. Completed Intersection Bridge 5.

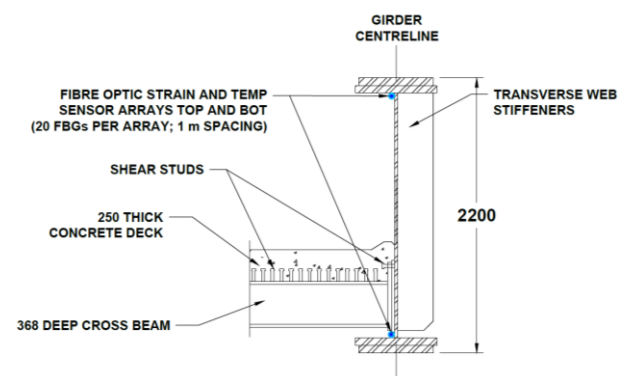
Figure 3. FBG sensor layout on typical main girders.

FBG sensors were installed along the top and bottom flanges of both main girders. Additional routing cables were spliced to the main sensor cables and terminated in a central cable enclosure mounted at the side of the bridge abutments where monitoring equipment was set up. Figure 3 depicts the locations of where FBG sensor cables were installed on the main girders.

Deployment of the sensor network took place over a three day period in May 2015 and a two day period in July 2015 immediately prior to casting of the concrete deck. The main superstructure sensor cables were attached to the underside of the top flange and on the top surface of the bottom flange in both the main girders. A high strength two-part

epoxy was used to bond the cables to the steel surfaces. The FBGs installed in the concrete deck were attached to the top layer of transverse reinforcing using plastic cable ties spaced at approximately 300 mm centres. A total of 160 FBG sensors (temperature and strain) were installed on the main bridge girders.

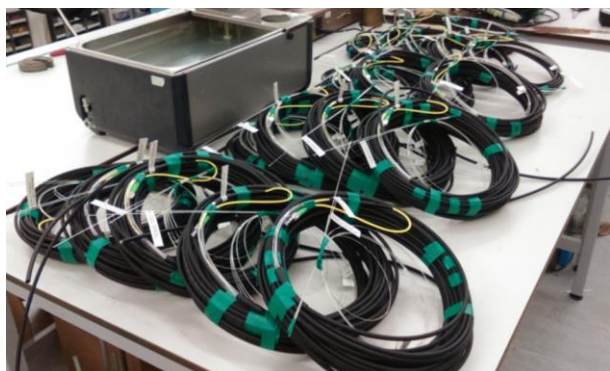
Figure 4. Laboratory prepared FBG sensor cables.

Due to the high-paced nature of the bridge construction schedule, all sensor cables were prepared prior to going to site to expedite their installation. This included labelling, measuring and splicing the main sensor cables to routing cables. In addition, a set of studies were undertaken to improve overall robustness of the sensor system using the laboratory facilities at the University of Cambridge. These included developing specially-fabricated flexible splice protectors and undertaking controlled calibration experiments for determining factors outlined in equation 1. The prepared sensor cables ready for deployment on site are shown in Figure 4.

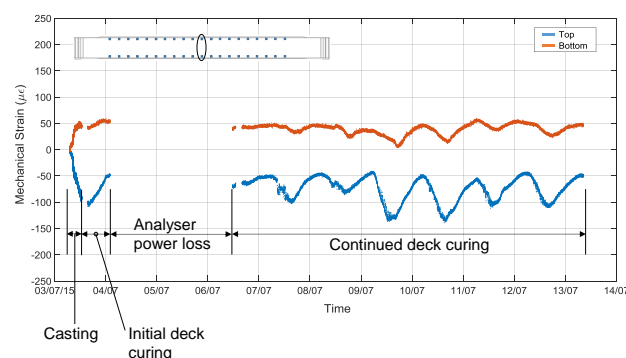
Figure 5. Overview of monitoring stages (West main girder mechanical strain development during)

deck casting and curing; baseline=pre-deck casting; positive strain indicates tension)

Figure 5 is used to illustrate the various monitoring stages undertaken. Following casting, there was an approximate two hour period where there was a long delay in the delivery of concrete and therefore, data acquisition was interrupted and resumed afterwards. Curing was monitored starting at approximately 12:45pm on 3 July 2015 and continued until 8:00am on 13 July 2015. Figure 5 also depicts a large three day gap in the curing monitoring data which was due to a power cut over a weekend period. Curing monitoring subsequently continued for the remaining 7 days. A clear distinction between top (negative = compression) and bottom (positive = tension) strains is discernible for the duration of the monitoring. Following initial casting, there is a consistent diurnal variation in strains that varies between 10 and 50 microstrain for the bottom flange and between -45 and -130 microstrain for the top flange. Although the strain values reported have been compensated for temperature effects, it appears that some latent effect of temperature is still influencing the results. The top of the girder is exposed to direct sunlight whereas the bottom is in constant shade. Therefore, the observed strain variations between the top and bottom girder indicate that temperature may still be influencing the results. Additional discussion of the thermal effects transferred from connected structural elements is discussed in more detail in Section 4.1.

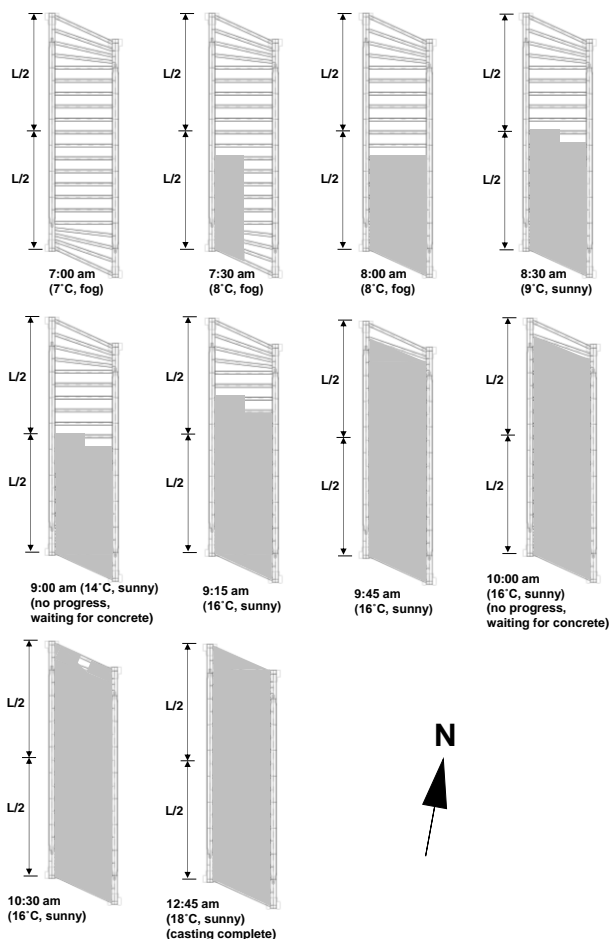
Figure 6. Deck casting sequence and recorded ambient temperature data.

As previously described, the deck casting took place over approximately four hours. Concrete was placed using a portable pumping vehicle fitted with an articulated nozzle. A detailed record of the casting sequence along with the recorded ambient weather conditions is presented in Figure 6. There were eight separate casting stages representing periods of time between concrete pump refilling. Real time strain development within both main girders was recorded for the entire casting process. Data was collected every second (1 Hz) for each FBG sensor (80 FBGs per girder) which provided a highly detailed view of each girders behaviour.

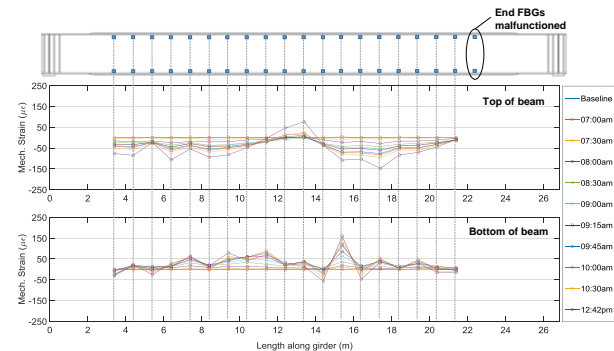
Figure 7. Evolution of strain profile during deck casting for the East Main Girder (baseline = pre deck casting; positive strain indicates tension)

Figure 7 presents the top and bottom strain profiles at each stage of the deck casting sequence. Note

that the strain data presented has been compensated for temperature changes and thermal strain changes in the main girder using equation 1. During the monitoring process it was noticed that the last sensors on the main east girder were malfunctioning and therefore, data is not available for these sensors during monitoring of the deck casting or curing (refer to Figure 7).

Overall, it appears that both girders exhibit fairly similar behaviour as the deck casting progresses where additional compression and tension is introduced into the top and bottom flanges, respectively. The data also reveals sections along the beam where the strain profile is non-uniform, that is, the top flange appears to be placed in tension (or experiences a reduction in compression) during certain stages and the bottom flange undergoes compression (or experiences a reduction in tension). There may be several reasons to explain the data described in Figure 5, Figure 7 and Figure 8. Firstly, it is important to note that since the sensors were installed on the pre-

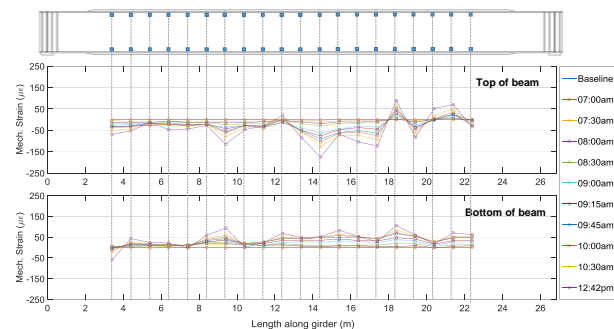
Figure 8. Evolution of strain profile during deck cast for the West Main Girder (baseline = pre-deck casting; positive strain indicates tension).

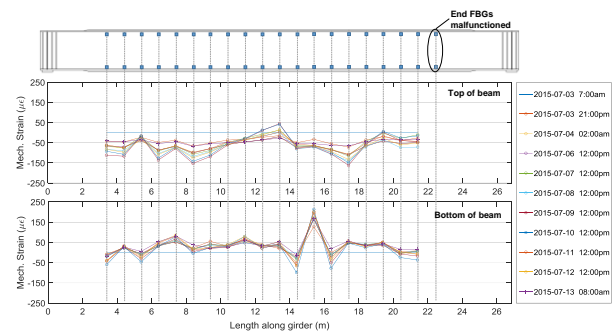
Figure 9. Evolution of strain profile during deck curing process for the East Main Girder (baseline = pre deck casting; positive strain indicates tension).

Following casting of the concrete deck, sensor readings were acquired for another seven days to record the effects of deck curing on the strains within the main girders. Figure 9 and Figure 10 present the strain development along both the east and west main girders, respectively for the first seven days after deck casting. Note that the strain changes presented are with respect to the original pre-deck casting baseline, that is, they represent

incremental strain values. To provide consistency in the reported results, the strain profiles reported all correspond to sensor values reported at 12:00pm on each day of curing. While the strain profiles within both girders seem to fluctuate along their lengths, their distribution seems to be similar to those captured at the end of the casting process (i.e., similar locations of peaks and valleys). This infers that these are permanent strains developed within the girders due to the casting and curing of the concrete deck. As described above, the mechanical strain results presented do not include the self-weight of the main superstructure elements and therefore, the strains presented do not represent the absolute strain within the girders. In addition, the secondary thermal effects due to the connected concrete deck (as described above) are not accounted for within the reported mechanical strains.

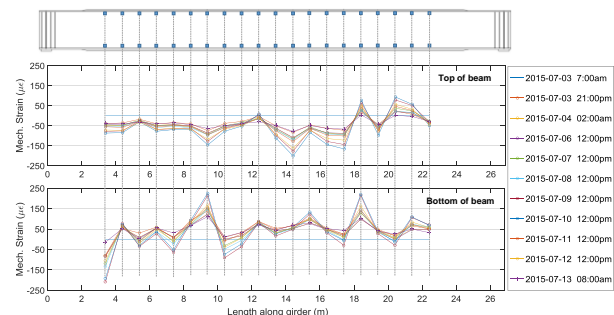
Figure 10. Evolution of strain profile during deck curing process for the West Main Girder (baseline = pre deck casting; positive strain indicates tension).
